# NAVAL POSTGRADUATE SCHOOL

# PROGRESS REPORT

THE RESPONSE AND FAILURE MECHANISMS OF CIRCULAR METAL AND COMPOSITE PLATES SUBJECTED TO UNDERWATER SHOCK LOADING

01 October 1988 - 30 September 1989

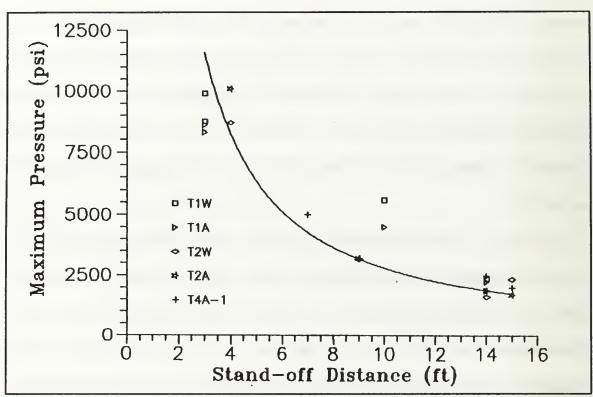
Figure 20. Comparison of the Peak Recorded Pressures with the Predicted Pressure Trace for the Five Pound TNT Charges.

As shown in Figure 20 and Figure 21 the measured maximum pressures at each pressure transducer were in good agreement with the predicted pressures of equation (1) with the exception of the peak pressures recorded by transducer number three for Test 1. The indicated stand off distance for this transducer is ten feet. A review of the pressure history plot for this transducer indicated that approximately 1.6 msec elapsed before the arrival of the shock wave. Using a nominal value of 4900 feet per second for the speed of sound in water, the calculated stand off distance for this transducer was determined to be 7.84 feet. The large discrepancy between the calculated and measured peak pressure for transducer number three in Test 1 was most likely due to an error in positioning the transducer.

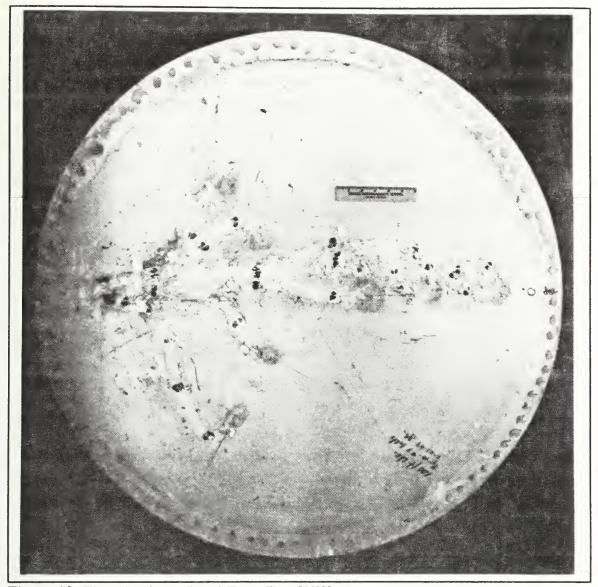
Figure 22. The Aluminum Panel From Test T1W.

The water backed test panels showed little or no damage from the underwater explosions regardless of the charge weight used. As shown by Figure 22 the aluminum plate of test T1W was unaffected by the shock wave produced by five pounds of TNT. No noticeable deformation was noted in the composite plates subjected to the shock from five pounds of TNT in test T2W and to the shock from ten pounds of TNT in test T3W. The most significant effect on the water backed panels was noted in the composite panel from test T2W. A crescent shaped internal delamination located at the top of the panel was

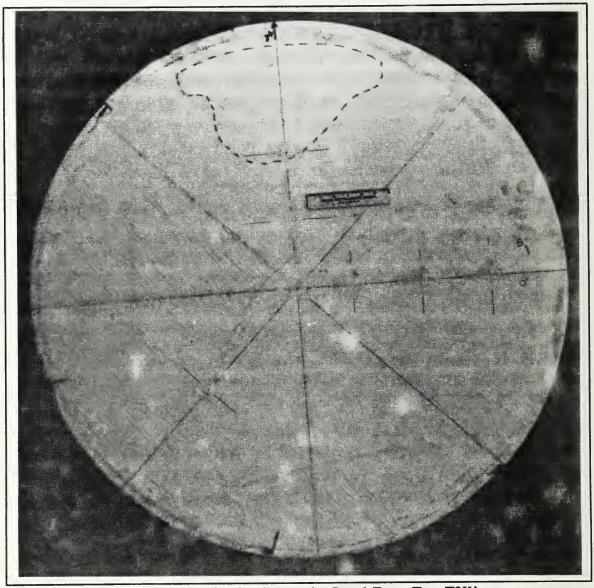
Figure 23. The [0°/90°/0°/90°/0°]<sub>s</sub> Composite Panel From Test T2W.

visible when the panel was back lighted. From the shape and location of the delamination, it appeared to have been caused by a trapped air bubble that allowed that section of the panel to flex more than the water supported sections surrounding it. The water backed test fixture vents that were supposed to allow air to escape from behind the test panel were carefully inspected and verified clear prior to test T3W. No delaminations were found in the composite panel following that test even though a ten pound charge was detonated. The composite panels used in test T2W and T3W are shown in Figure 23 and Figure 24.

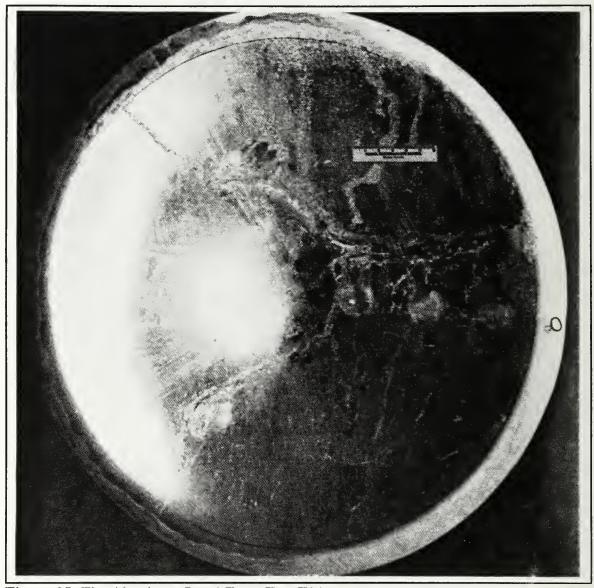
Figure 25. The Aluminum Panel From Test T1A.

As anticipated, the effect of the underwater explosions was much more pronounced on the air backed panels than on the water backed panels. The aluminum test panel of test T1A, shown in Figure 25, exhibited a conical shape following the shock wave from the five pound charge of TNT. All of the composite panels used in the air backed tests T2A, T3A, T4A-1, and T4A-2 showed significant permanent transverse deformation and localized rupture of the matrix material.

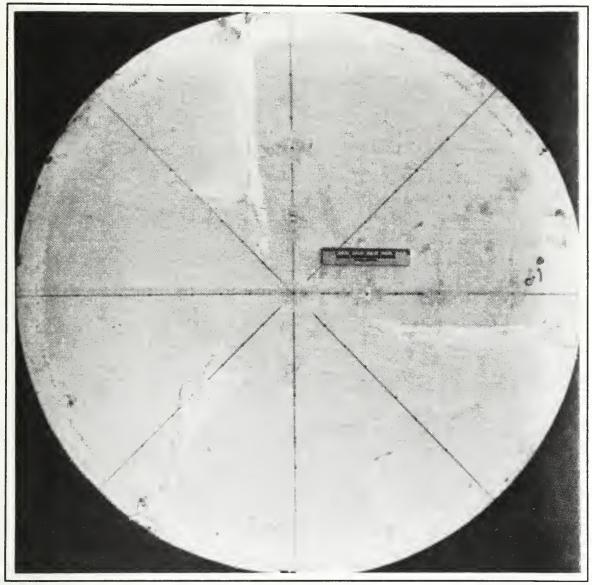
Figure 26. The  $[0^{\circ}/90^{\circ}/0^{\circ}/90^{\circ}/0^{\circ}]_{S}$  Composite Panel From Test T2A.

The composite panels of the five pound charge tests, T2A and T4A-1, exhibited an appearance similar to the aluminum panel of T1A but were not as obviously conical shaped. As shown in Figure 26 and Figure 27, each of the panels had generally radially oriented narrow strips of localized matrix rupture that appeared to initiate at the outer edge of the panel and to propagate toward the center of the panel. The fiber rovings in these regions of matrix failure appeared to have buckled away from the central layers of the panel. An edge on view of each of the failure regions showed that the matrix failure occurred at an angle to the thickness of the panel as illustrated by Figure 28. The visual

evidence suggests that the brittle matrix material failed due to excessive compressive stress imposed in the circumferential direction.

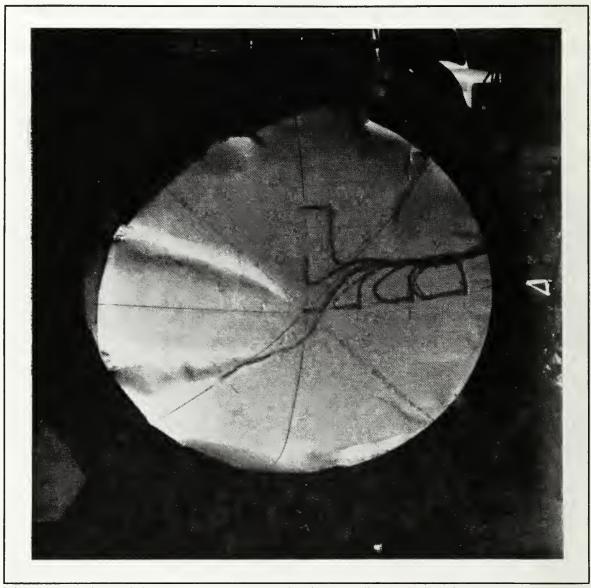
Figure 29. View of the Test Panel From T4A-2 Immediately Following the Test.

The composite panels subjected to the shock wave from the ten pound charges used in tests T3A and T4A-2 deflected to such an extent that one edge of the panel was pulled free of the clamp rings. When this occurred the panels were forced into the bottom

of the test fixture. Figure 29 shows the test panel from T4A-2 while still in the test fixture. One mode of failure for these panels was still the radially oriented strips of localized matrix rupture apparently due to compressive stresses in the circumferential direction. Superposed on this failure mode was a second mode consisting of generalized

delamination of the panel due to the severe bending and folding of the panel when it was forced into the bottom of the fixture.

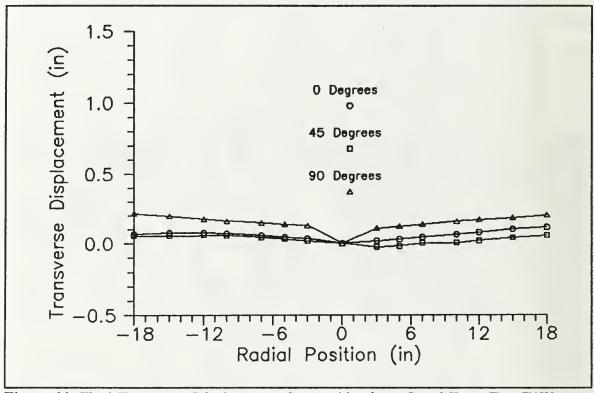
Figure 31. Final Transverse Displacement for the Aluminum Panel From Test T1W.

The final transverse displacement of the aluminum panels used in tests T1W and T1A are shown in Figure 31 and Figure 32. The displacement pattern for both cases is

symmetric about the center of the panel. The water backed panel of T1W was essentially undeformed by the explosion. It was unclear whether the 0.2 inch deflection measured along the 120° traverse at the center of the panel represented a permanent distortion of the panel or was caused by hysteresis in the radial motion of the panel edge due to interference from the gasket material.

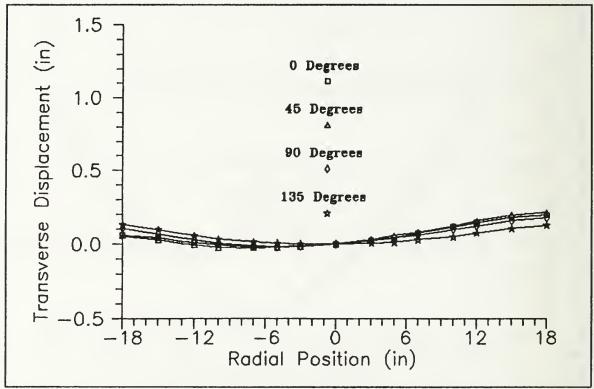
Figure 33. Final Transverse Displacement for the [0°/90°/0°/90°/0°]<sub>s</sub> Composite Panel From Test T2W.

The final transverse displacements of the test panels from tests T2W and T3W are shown in Figure 33 and Figure 34. Measurements indicated that the panel from T2W had a maximum permanent deflection of 0.12 inch at the panel center. This panel had suffered an internal delamination in the upper portion of the panel due to the effects of an

air bubble trapped behind the plate. The small transverse displacement of this plate was judged to be a result of the internal delamination. The panel from T3W which was exposed to the shock produced by the detonation of ten pounds of TNT had negligible permanent transverse displacements.

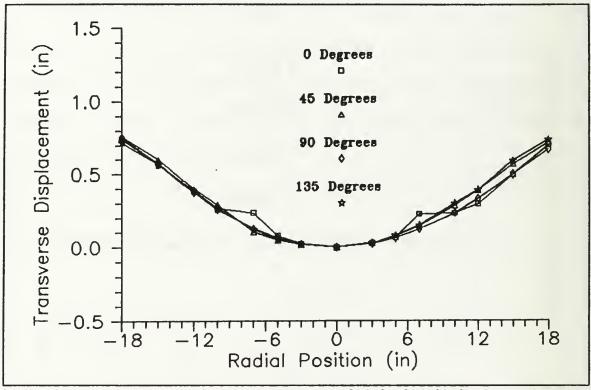
Figure 35. Final Transverse Displacement for the [0°/90°/0°/90°/0°]<sub>s</sub> Composite Panel From Test T2A.

No transverse deflection measurements could be taken from the test panels used for the ten pound charge tests T3A and T4A-2. The final transverse displacement of the panels from T2A and T4A-1 are shown in Figure 35 and Figure 36. The peak deflection measured at the center of the panel from test T2A was 0.75 inches. The deflected shape of the panel was generally symmetric about the center of the panel. It approximated a surface of revolution, but appeared to be more parabolic than conical in shape. The

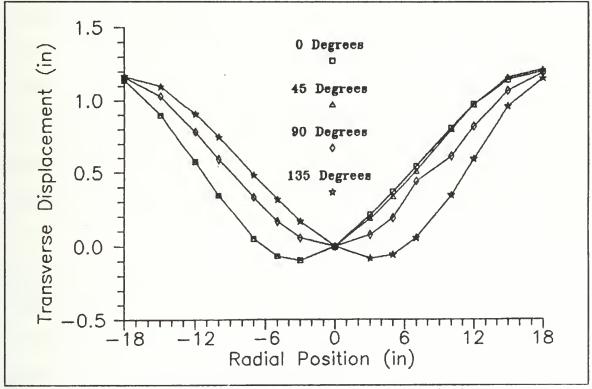
Figure 36. Final Transverse Displacement for the [0°/90°/45°/90°/0°]<sub>s</sub> Composite Panel From Test T4A-1.

maximum permanent deflection of the panel from T4A-1 was 1.26 inches. The deflected shape was skewed to one side so that the maximum deflection occurred at a point three inches to the left of the center of the panel on the 0° traverse.

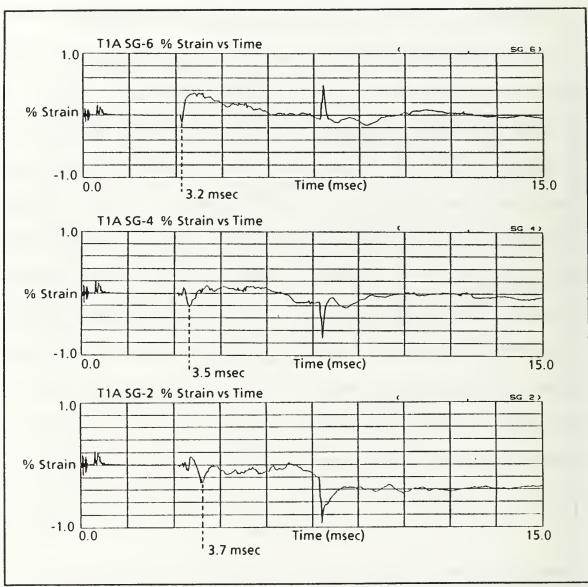
Figure 38. Progress of the Plastic Bending Wave for Test T1A.

Examination of the radially mounted strain gages provided information on the passage of the plastic bending wave through the panel. As shown in Figure 38, evidence of the plastic bending wave first appears on strain gage 6. The tensile strain produced at shock wave impact at 3.1 msec is abruptly reversed at approximately 3.2 msec. The strain reversal was due to the relatively short radius of curvature of the bending wave. This placed the upper surface of the panel in radial compression. As the bending wave passed strain gage 6 the compressive strain was relieved as the radius of curvature increased. The bending

wave arrived at strain gages 4 and 10, located ten inches from the panel center, at 3.5 msec and arrived at strain gages 2 and 8, located five inches from the panel center at 3.9 msec. Permanent radial strain was maximum near the center of the panel, probably as a result of the slight thinning of the material in the central region of the panel characteristic of metal panels deformed by underwater shock.

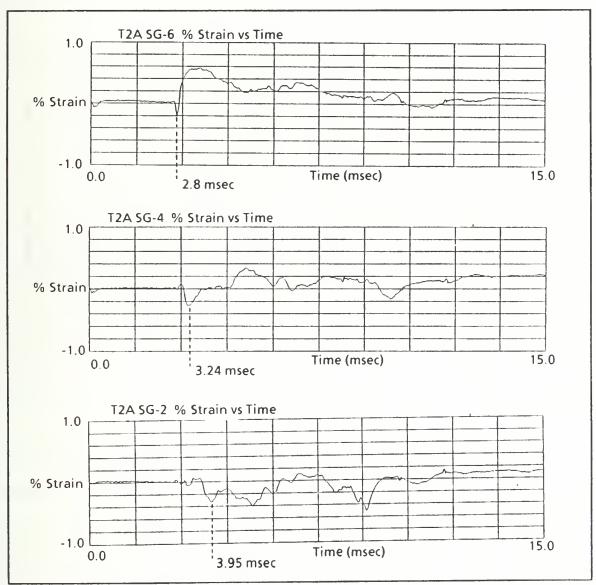
Figure 39. Progress of the Bending Wave for Test T2A.

The short time strain histories from T2A were compared to the corresponding strain histories from T1A. An attempt to overlay the pattern of failure noted in T1A met with limited success. As shown in Figure 39, what appeared to be the corresponding phenomena in the composite material of the plastic bending wave in the aluminum can be seen arriving at strain gage 6 at a total elapsed time of 2.8 msec, strain gages 4 and 10 at

3.24 msec, and strain gages 2, 8 and 12 at 3.95 msec. Next, the circumferentially mounted strain gages were examined to determine the time to peak transverse extension. As shown in Figure 40, strain gage 7 exhibited a peak at 5.05 msec that appeared to represent maximum transverse extension. Unlike T1A, none of the other circumferentially mounted strain gages corroborated this time.

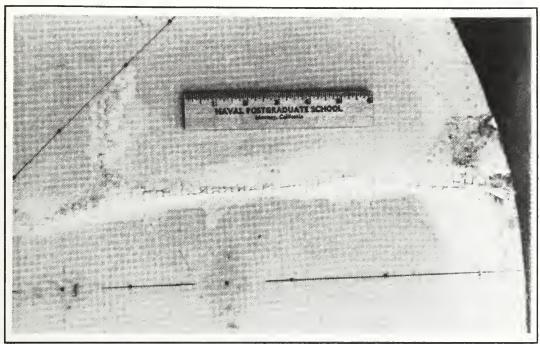
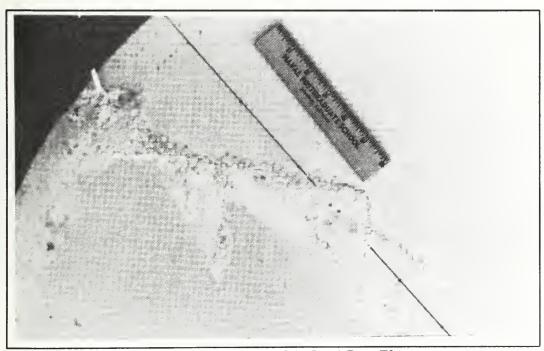
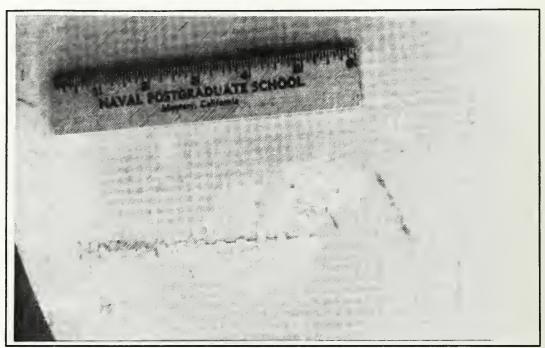
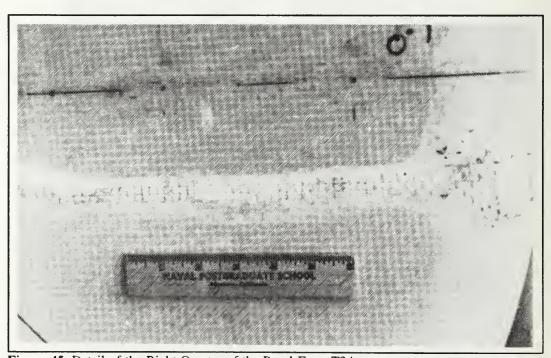
panels were constrained from bending by the portion of the panel that stayed within the clamp rings. A small amount of breakage was also found at the outer end of the radial matrix failures on the panels used for the five pound charge air backed tests.

Figure 42. Detail From the Upper Quarter of the Panel From T2A.

Figure 43. Detail From the Lower Left Quarter of the Panel From T2A.

Figure 44. Detail of the Lower Right Quarter of the Panel From T2A.

Figure 45. Detail of the Right Quarter of the Panel From T2A.

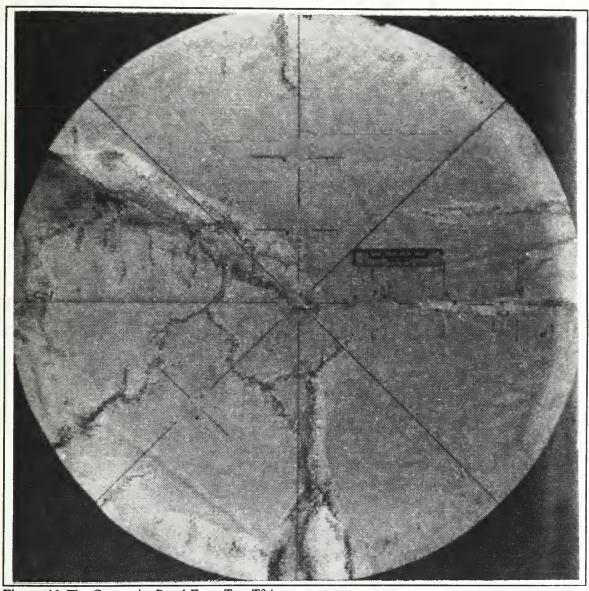
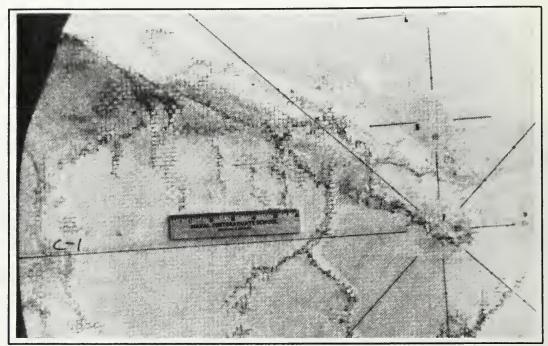
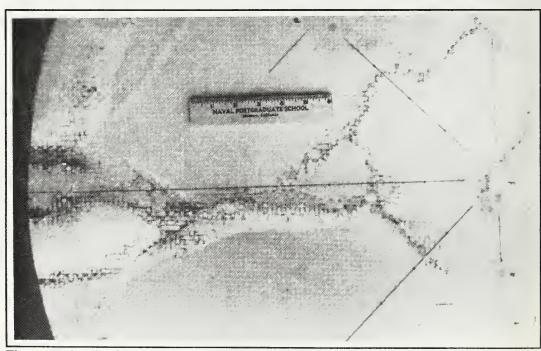
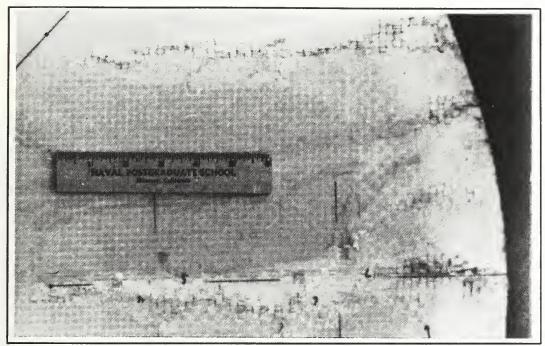
As shown in the detailed photographs found in Appendix B of the damaged areas, glass fiber breakage in all of the composite panels was minimal. The primary locations for fiber breakage were on the panels from T3A and T4A-2 where the composite

Figure 46. The Composite Panel From Test T3A.

Figure 47. Detail of the Left Quarter of the Panel From T3A.

Figure 48. Detail of the Lower Quarter of the Panel From T3A.

Figure 49. Detail of the Right Quarter of the Panel From T3A.

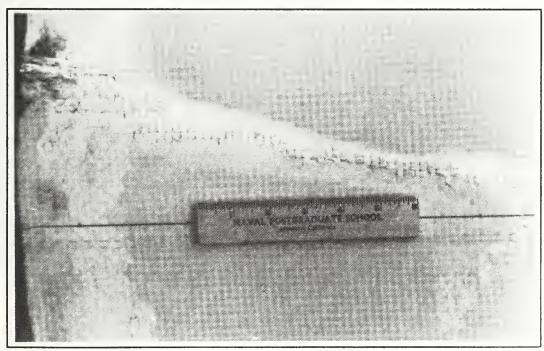
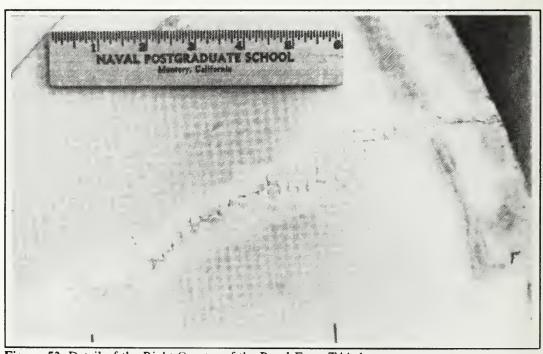
Figure 50. Detail of the Left Quarter of the Panel From T4A-1.

Figure 51. Detail of the Lower Quarter of the Panel From T4A-1.

Figure 52. Detail of the Right Quarter of the Panel From T4A-1.

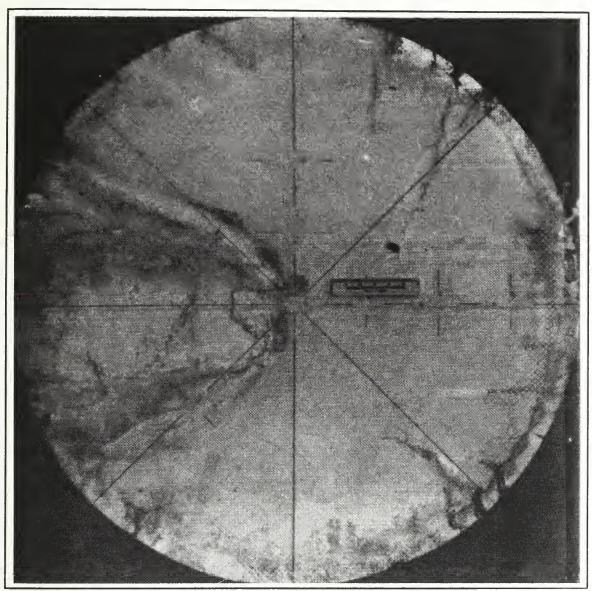
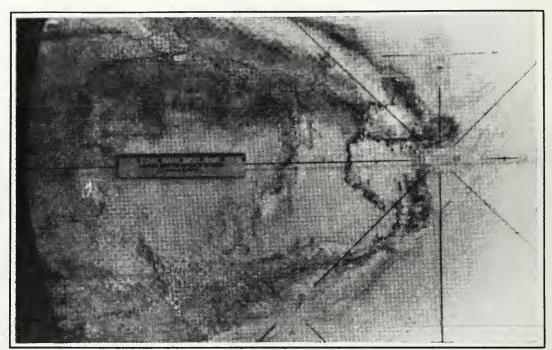
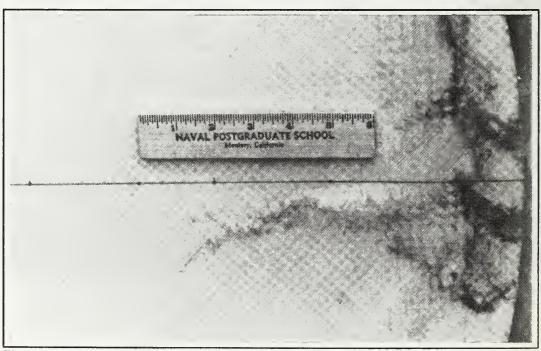
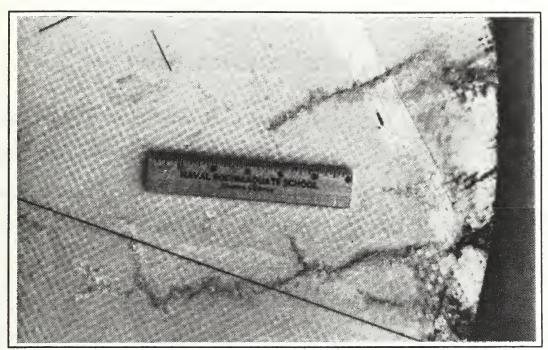
Figure 53. The Composite Panel From Test T4A-2.

Figure 54. Detail of the Left Quarter of the Panel From T4A-2.

Figure 55. Detail of the Lower Right Quarter of the Panel From T4A-2.

Figure 56. Detail of the Upper Right Quarter of the Panel From T4A-2.
